Watershed Based Plan for the Upper Rio Grande Watershed, Comanche Creek Subwatershed

Professional Services Contract # 17-667-2060-0005

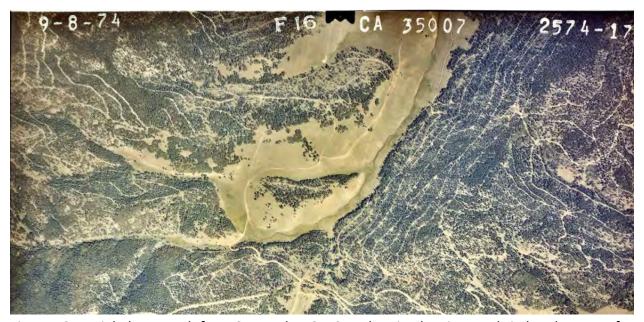
1989). Jammer cables have a limited reach of 100 to 300 feet; therefore requiring the construction of closely-spaced roads— in this instance, every 150 feet. Timber harvesting and the subsequent construction of many logging roads further impacted the watersheds of the Valle Vidal. Logging road construction resulted in changed water drainage patterns throughout the watershed. These road networks are clearly visible in aerial photos (Fig. 10). More than 700 miles of abandoned logging roads were drained and closed to traffic in the two years following acquisition of the Valle Vidal Unit by the USFS in 1982.

Figure 10. Aerial photograph from September 8, 1974 showing logging roads in headwaters of Comanche Creek (southernmost portion of the watershed)

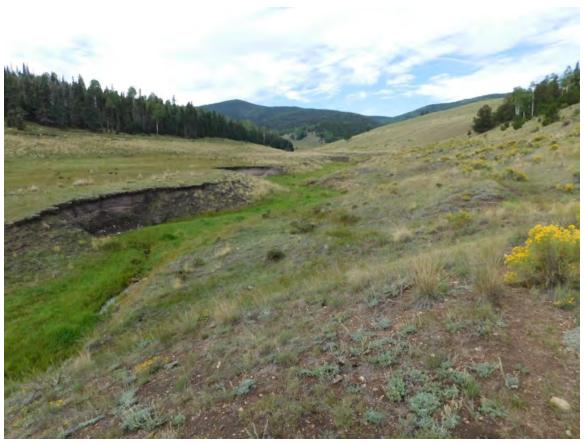
The current condition of CCW creeks, wetlands, and wet meadows, and of its tributaries, is a product of past human land use within the watershed. This historical use has contributed to a significant amount of soil erosion, increase in sediment load in the streams, increases in stream water temperature, and overall degradation of riparian and wetland ecosystem services (Fig. 11).

Figure 11. Current conditions in Gold Creek in August 2018 showing downcut and incised channel with abandoned wetland floodplains

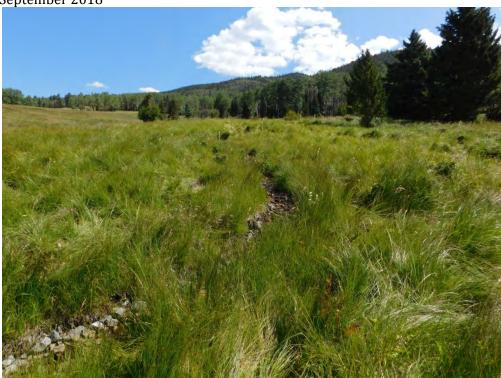
August 2019. Restoration treatment addressed an incised secondary channel through valley wetlands. High banks were collapsed and the new channel profile was armored with angular cobble.

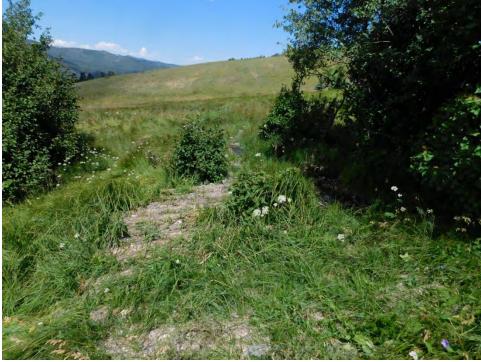
August 2019. Restoration treatment included an in-channel log flow splitter in the main channel to lift the channel and to spread water to a log and rock berm that directs surface water to valley right.

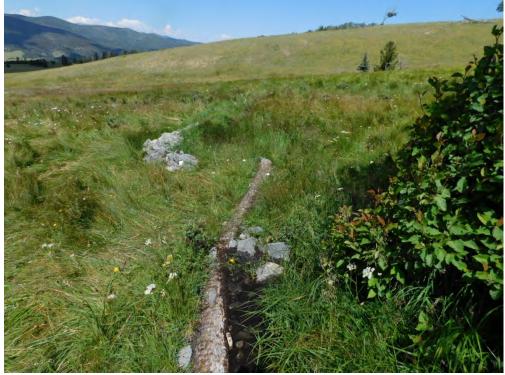
August 2019. Log and rock berm designed to move water toward the center of the valley

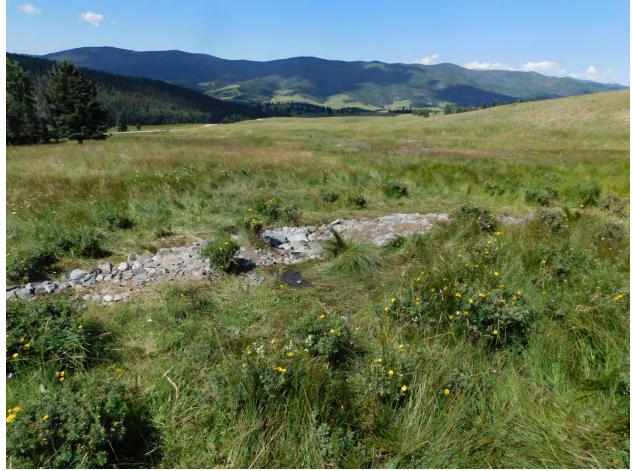
August 2019. A rock media luna was constructed to further spread from the flow splitter and lead out berm upvalley.

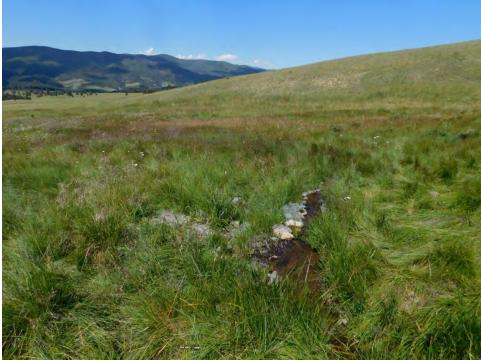
August 2019. A log mat flow splitter with rock armor was installed to move water to rewet a dried swale downslope at valley right.

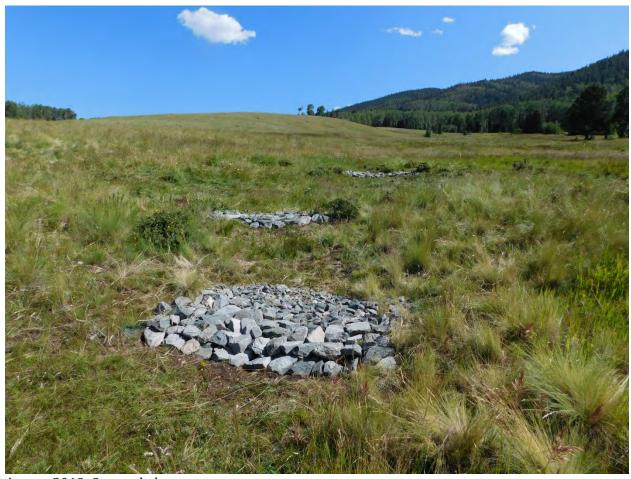
August 2019. One rock dams

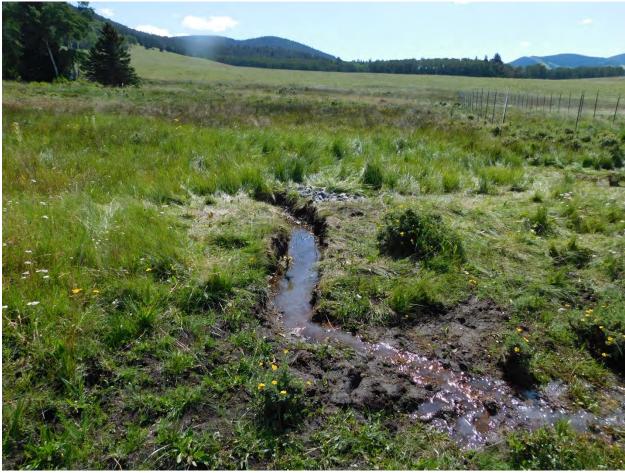
August 2019. Sod swale with rock-armoured stable return

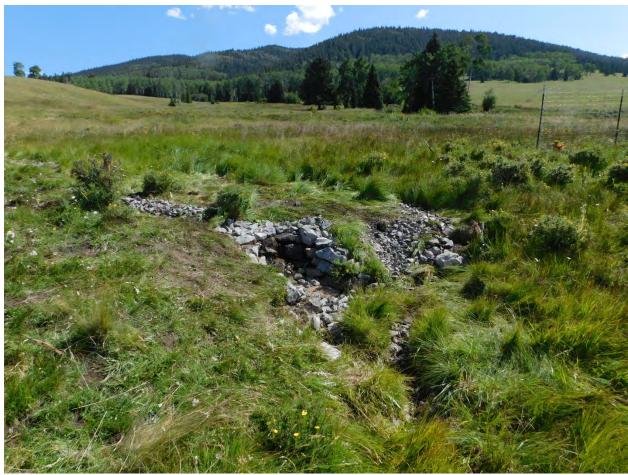
August 2019, Zuni Bowls and rock rundown to stabilize head-cutting and gully formation (2019 NMDGF Funding)

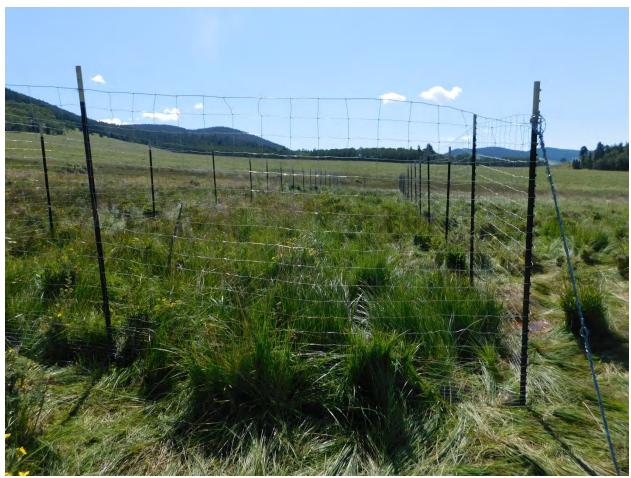
August 2019. Bebb willow exclosure, view from valley left to valley right

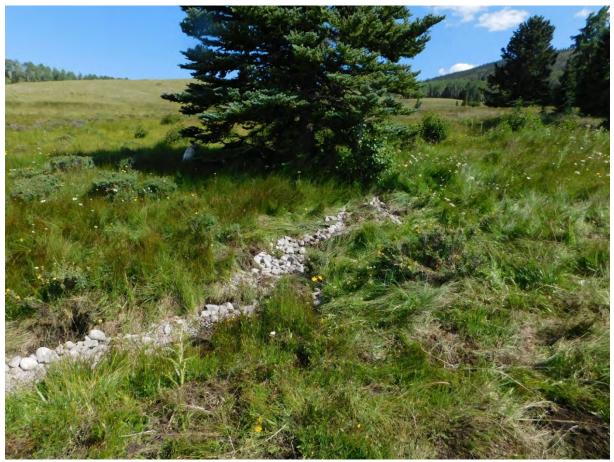
August 2019. Restoration treatment addressed an incised secondary channel through valley wetlands. High banks were collapsed and the new channel profile was armored with angular cobble (2019 NMDGF Funding).

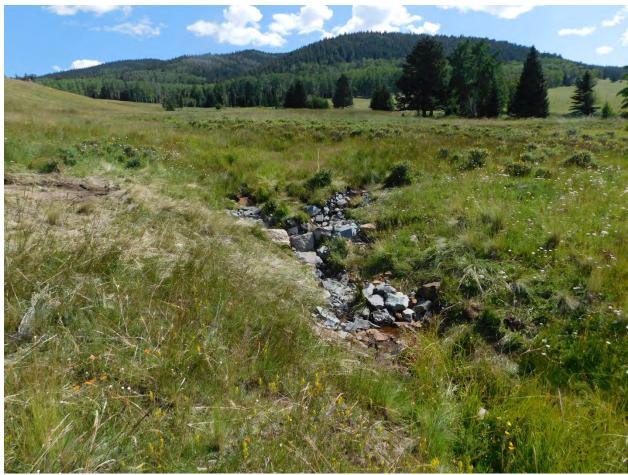
August 2019. Zuni bowl and large rock rundown constructed by Quivira volunteers and Reieneke Construction in 2019

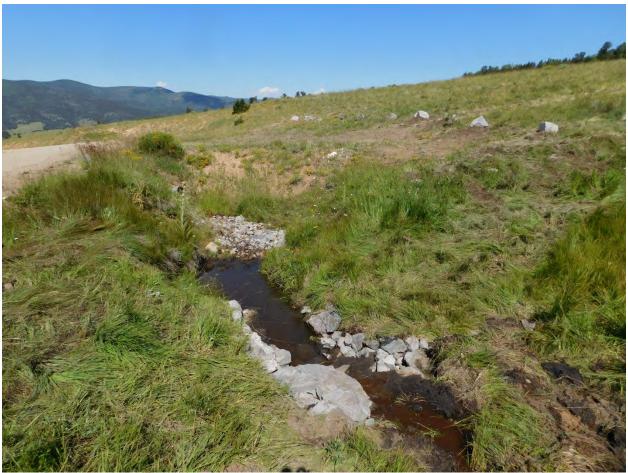
August 2019, Zuni Bowl and rock rundown to stabilize head-cutting and gully formation from Forest Service Road 1950 culvert (2019 NMDGF Funding)

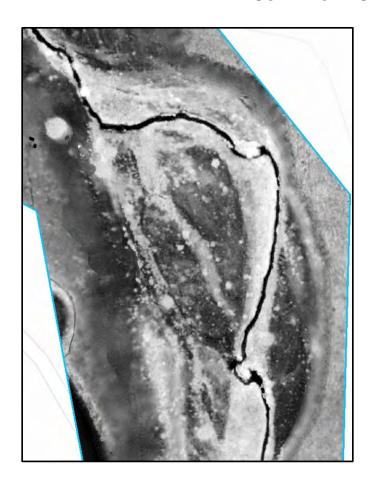
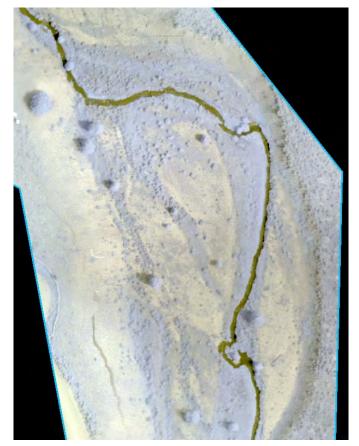
APPENDIX C – NORMALIZED DIFFERENCE VEGETATION INDEX (NDVI) IMAGERY OF COMANCHE CREEK MAINSTEM

The drone flight was conducted in August 2017, before the majority of in-channel work was completed on the mainstem of Comanche Creek by Watershed Artisans, Inc. using funds from Coca Cola and Intel. This imagery may provide a baseline for comparing vegetation health and productivity before and after restoration activities, as a proxy for increased soil moisture in riparian and slope wetlands as a result of restoration activities. Quivira or another member of the CCWG will seek another Patagonia grant in 2022 to repeat the drone flights to gather NDVI
